# Manhole Inspection Summary

Manhole # S39CC\_041MH

Insp Date: **3/23/09 10:31 AM**

**Location** Address: **901 VALLEY CT**

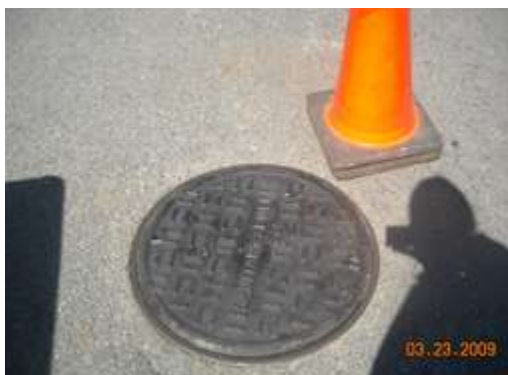
MISC.

REPLACED BROKEN COVER

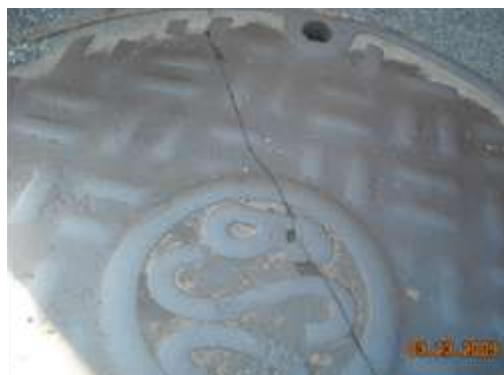
MISC.

Comments **BROKE AND REPLACED COVER TO COMPLETE INSPECTION (see photos)**

BROKE COVER IN OPENNING ATTEMPT

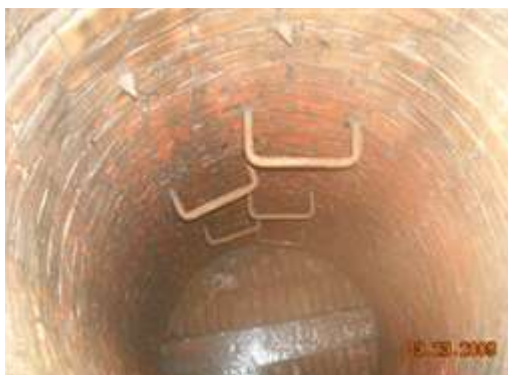
Defect 4

Count: **5**

Missing: **1**

☒ **Corroded**

CORRODED AND MISSING STEPS

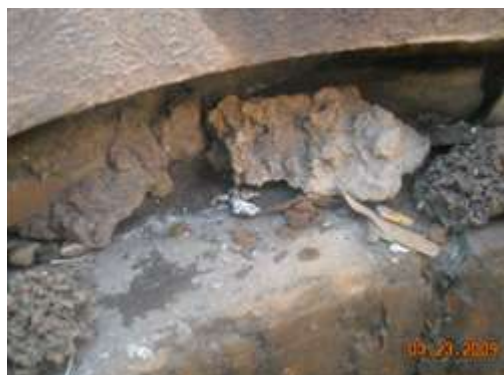
Defect 3

☒ **Deteriorated**

DETERIORATED CHIMNEY

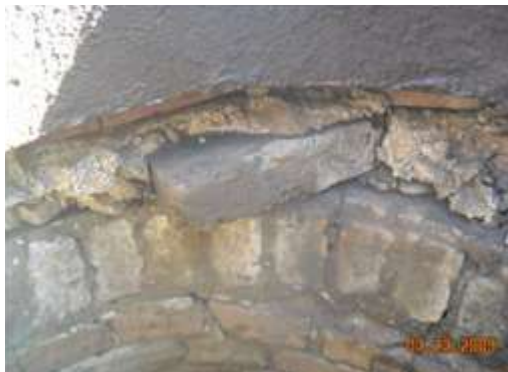
Defect 2

☒ **Loose Brick**

LOOSE CHIMNEY BRICKS

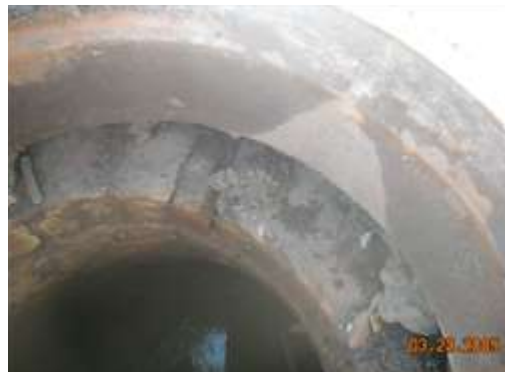
Defect 1

Offset: **5** (in.)

FRAME OFFSET

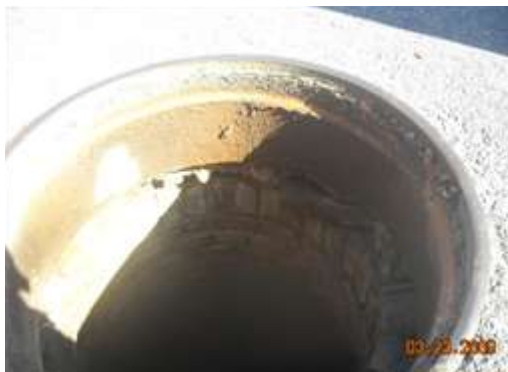
Defect 5

Subject To Ponding: **Sheeting**

INFLOW EVIDENCE FROM SHEETING

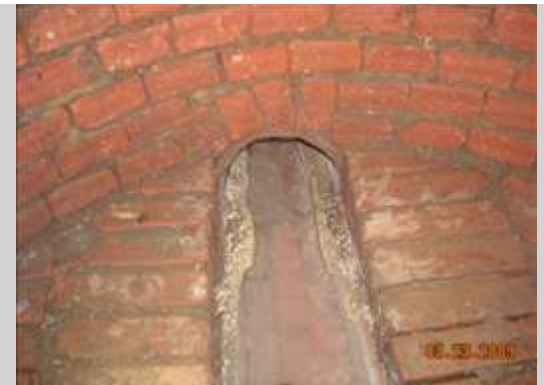
6 O'Clock Inflow

Pipe Height: **8.4** (in.) Rod and Bar (Angled)  
Pipe Material: **Clay** ☐ Pipe Lined  
Invert Depth: **10.75** (ft.) Flow Characteristics: **Fast**  
Deposits: ☐ None ☐ Mud ☐ Sludge ☐ Debris ☒ Grease  
Silt Depth: **2** (in.) Deposits Extent: **Light**  
Infiltration: **None** Pipe Seal Cond: **Sound**

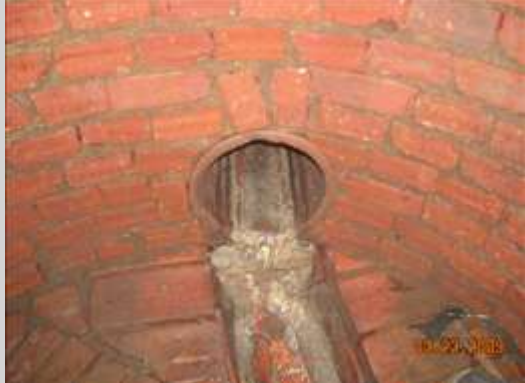
8 O'Clock Inflow

Deposits: ☐ None ☐ Mud ☐ Sludge ☐ Debris ☒ **Grease**

Silt Depth: **1** (in.) Deposits Extent: **Light**
